**IN THE HIGH COURT OF FIJI AT SUVA
CIVIL JURISDICTION**

Civil Action No. HBM No. 57 of 2022

AFFIDAVIT OF [REDACTED]

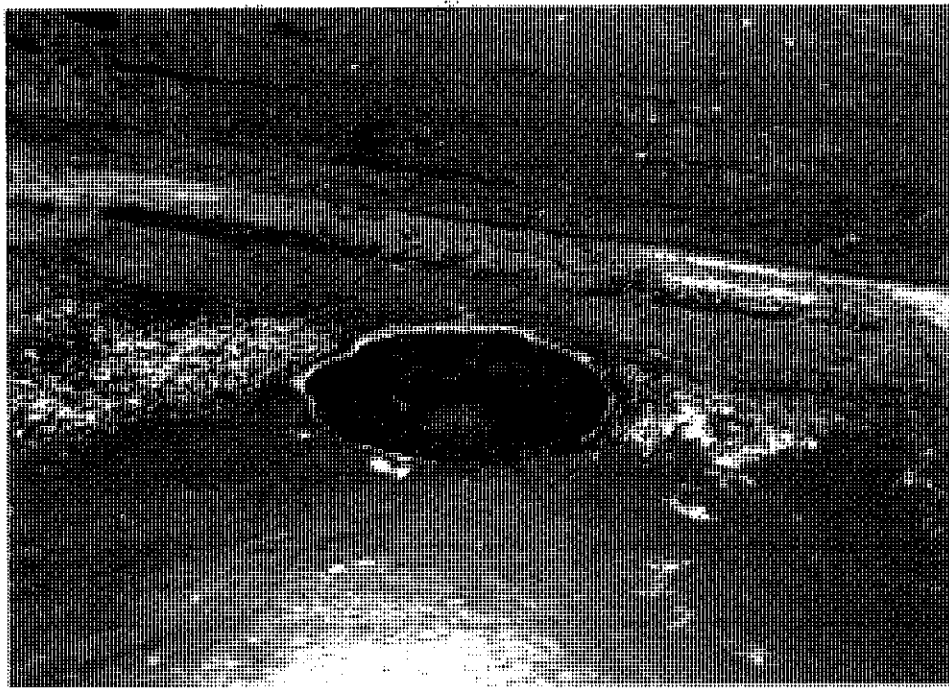
10. I hope the above gives a snapshot of the maintenance required. Our system has a total of 675 jobs recurring on calendar and running hours basis.
11. In addition to the above is the issue with the large pitting found in ballast tank VIA2 needs to be addressed. The pit is measuring approx. 8-9mm deep and approx. 30mm in diameter and it is unclear how much metal is left. Ship construction diagrams show the steel in this area to be 9mm so the remaining steel will be wafer thin.

12. I have an ultrasonic tester arriving on Saturday which will allow me to measure the remaining steel but given my experience from the dry dock last year, Lloyds Register will almost certainly request the vessel to be dry docked and the steel replaced.
